SPECTACULAR CARIBBEAN POOL

VIRGIN ISLANDS

The island of Culebra, part of the Virgin Islands, is a hidden jewel dangling off the coast of Puerto Rico, the first of a string of alluring havens that includes Antigua, Martinique and Barbados. Used by pirates as a hideout during the early stages of Spanish colonization, this piece of unscathed paradise eventually became one of the first National Aquatic Preserves and a National Wildlife Refuge, protected by the U.S. Fish & Wildlife Service. This idyllic setting provides the humbling vista surrounding a remarkable pool designed by DEN Architecture and built by Luis Lopez Pool Construction of San Juan.

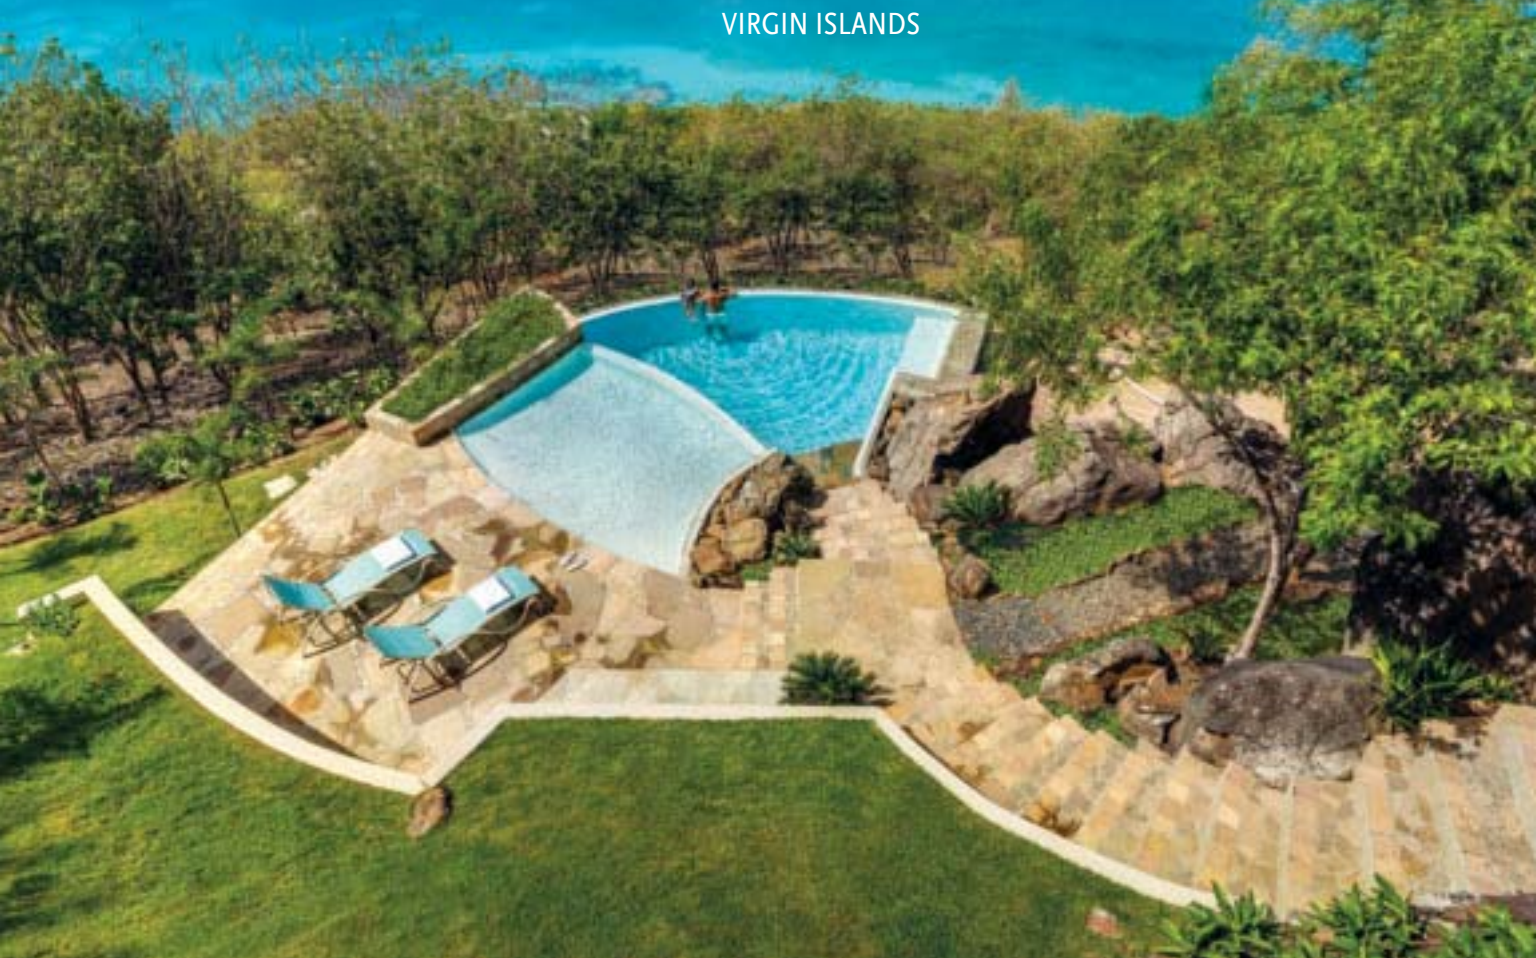
Foremost in the minds of Lizmarie Esparza, RA, and German Brun, AIA, the visionary architects of the project, were the sightlines to Cayo Luis Peña, the small, uninhabited island across the bay. The construction of the entire house and pool deck evolved to capture the view from different perspectives. Perhaps the most fascinating is the bifocal reflection of the evening sky provided by offset cascading pools, with the island serving as backdrop. (See the magazine cover and photo right.)

At the end of the winding platforms, and parallel to the lot's steep slope, the pool seamlessly blends with an unimpeded view of the Caribbean Sea. The pool hugs the mountain, adjusting to its pitch by dividing the pool into two components: a zero-entry wading pool and a plunge pool.

This two-step solution not only accommodates the slope, but also allows not one, but two cascading water surfaces to visually connect with the waters of the Cayo Luis Peña Aquatic Preserve below and the Caribbean Sea beyond it.

- The pool is divided into a zero-entry wading pool (18-inches at the deep end) and a plunge pool (6 feet at the deep end), divided by a retaining wall.
- Very little excavation occurred since the pool was built like a dam above the slope of the mountain.
- The bottom retaining wall has a very deep foundation consisting of continuously reinforced, extra-wide cast-in-place concrete footings. This wall, given its height from the bottom of the mountain, was covered with Seagrape vegetation to make it invisible from the sea.
- Despite appearances in some photos, the plunge pool does not have an infinity edge; it's just a slanted edge profile.

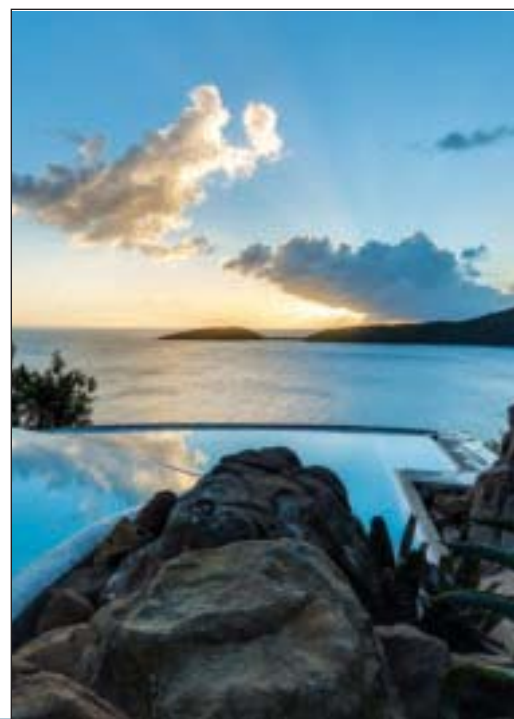
The large, dark boulders found on site became an indigenous building material

and helped integrate the project into its surroundings. For example, the dark stones are scattered throughout the main exterior staircase that connects the two independent structures that form the house.
